# Manhole Inspection Summary

Manhole # S53E\_\_004MH

Insp Date: **4/25/08 1:56 PM**

**Location** Address: **11 s highland ave**

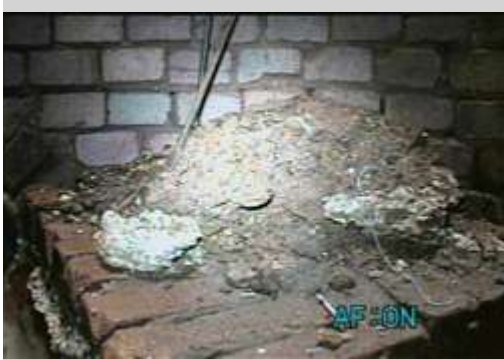
Defect 2

Condition: ☐ Sound ☐ Cracked ☐ Root Intrusion ☐ Deteriorated ☐ Leaks ☒ **Debris**

bench debris

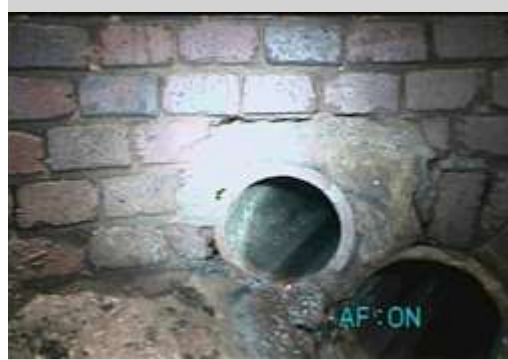
Defect 3

Condition: ☐ Sound ☒ **Cracked** ☐ Root Intrusion ☐ Loose Brick ☐ Deteriorated

barrel cracked

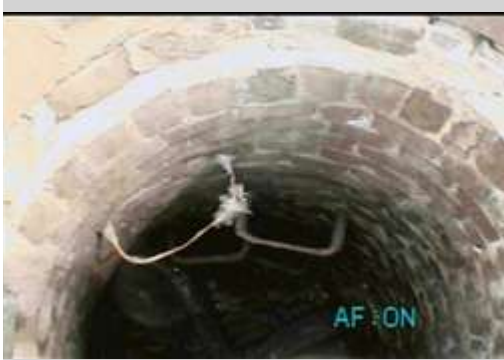
Defect 1

☒ **Corroded**

steps

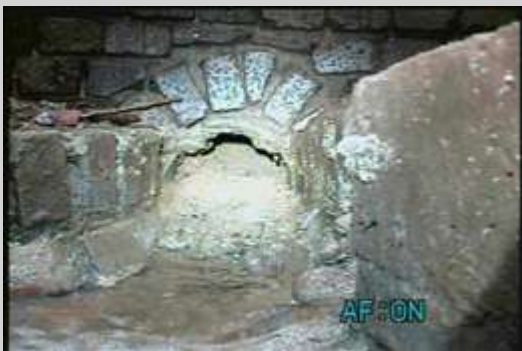
3 O'Clock Inflow

Deposits: ☐ None ☐ Mud ☒ Sludge ☒ Debris ☐ Grease

Silt Depth: 7 (in.) Deposits Extent: **Heavy**
